AFFCO IMLAY

**ANNUAL AIR
DISCHARGE
MONITORING REPORT –
2023 / 2024**

AFFCO IMLAY WANGANUI

AIR DISCHARGE PERMIT:-
ATH-2007010926.01

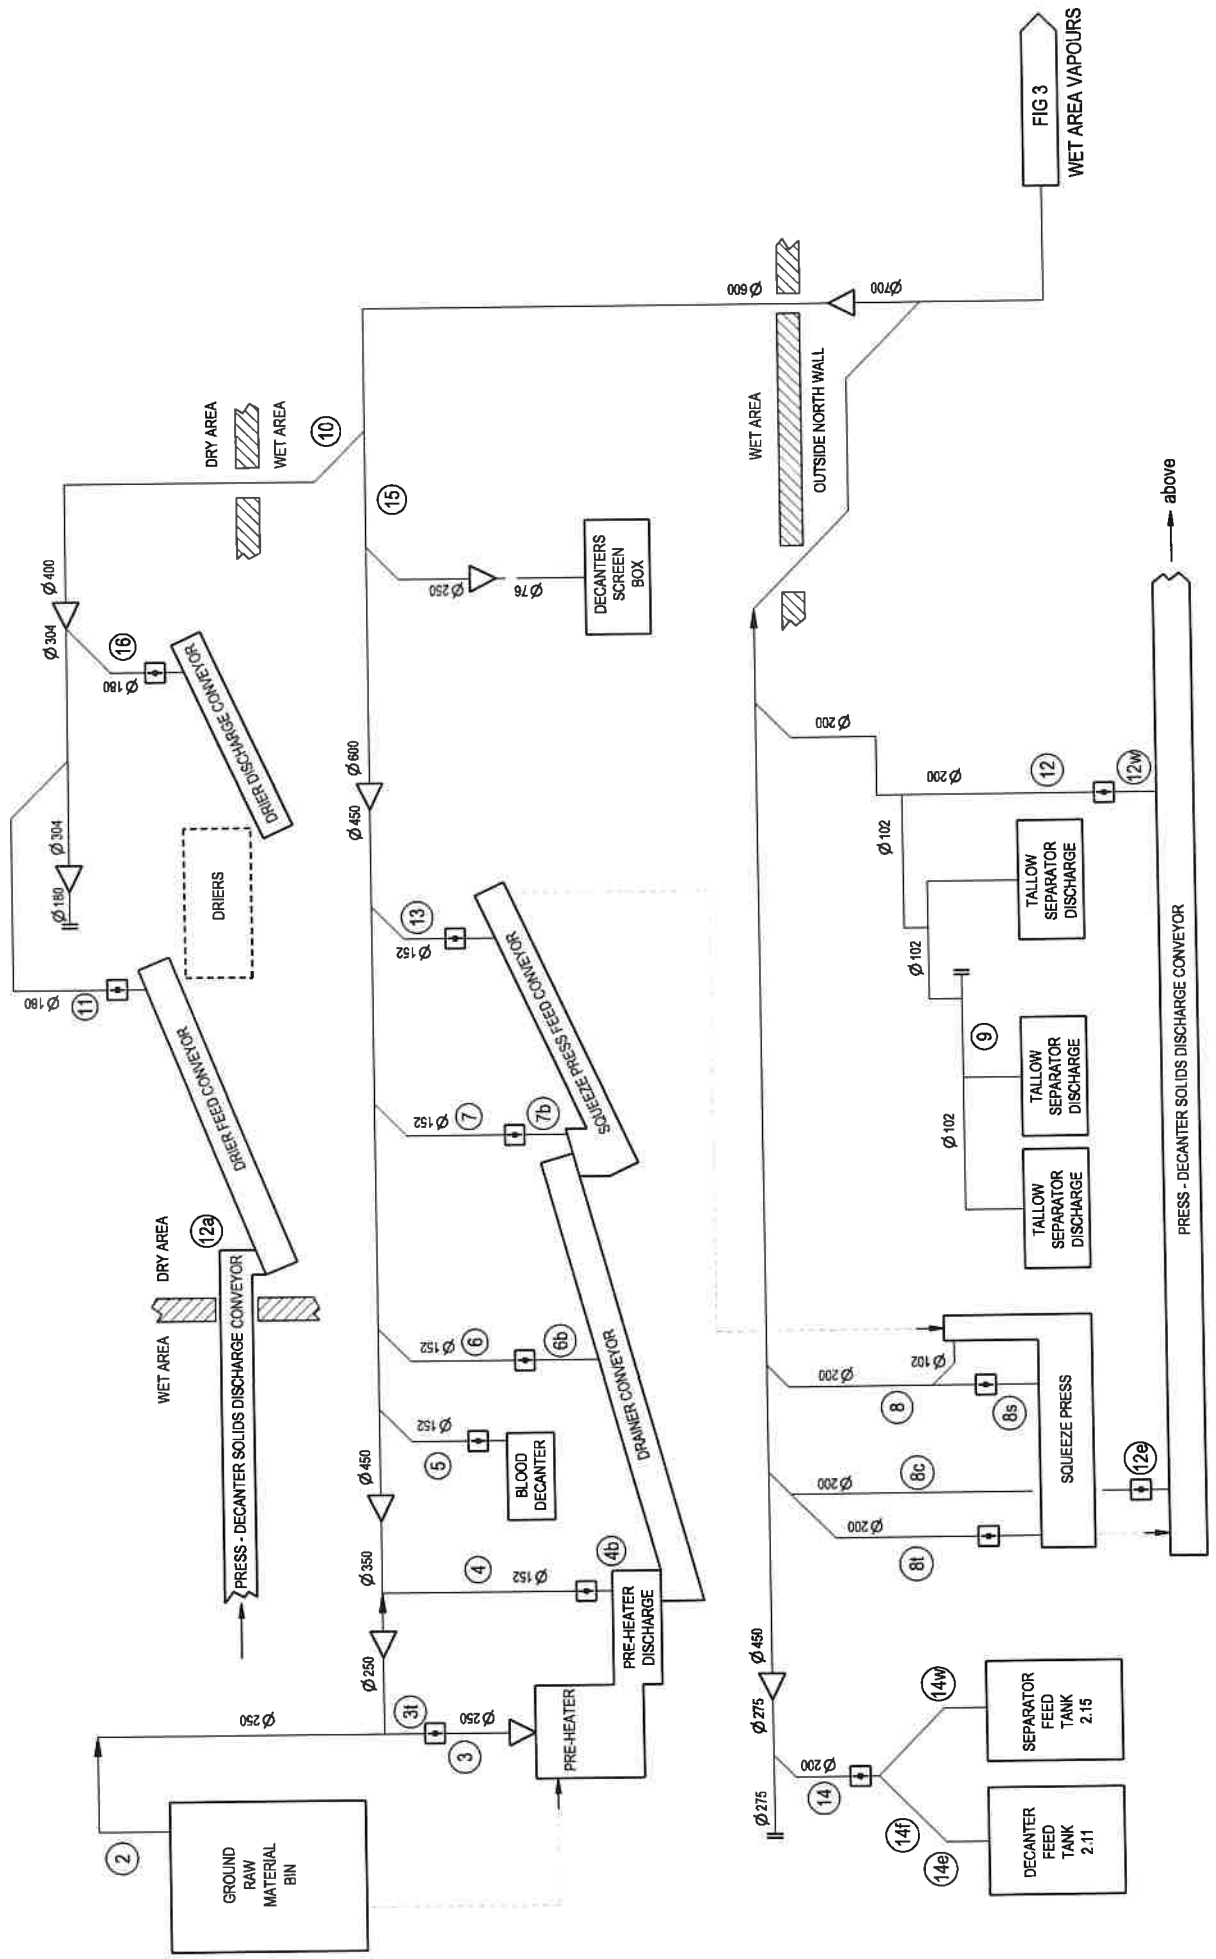
Fig 1. Wet Area Point Source Extractions at AFFCO Imlay Plant - Apr 2024

- 10 The extracted air from decanter solids conveyor goes to same manifold as the separators extracted air (see Fig 1). An objective has been to draw more air from the solids conveyor through adjustment of slide valve below port 12 to increase vacuum at the end of the conveyor located in the dry-area. Have not yet achieved the adjustment required. The cause still being investigated.

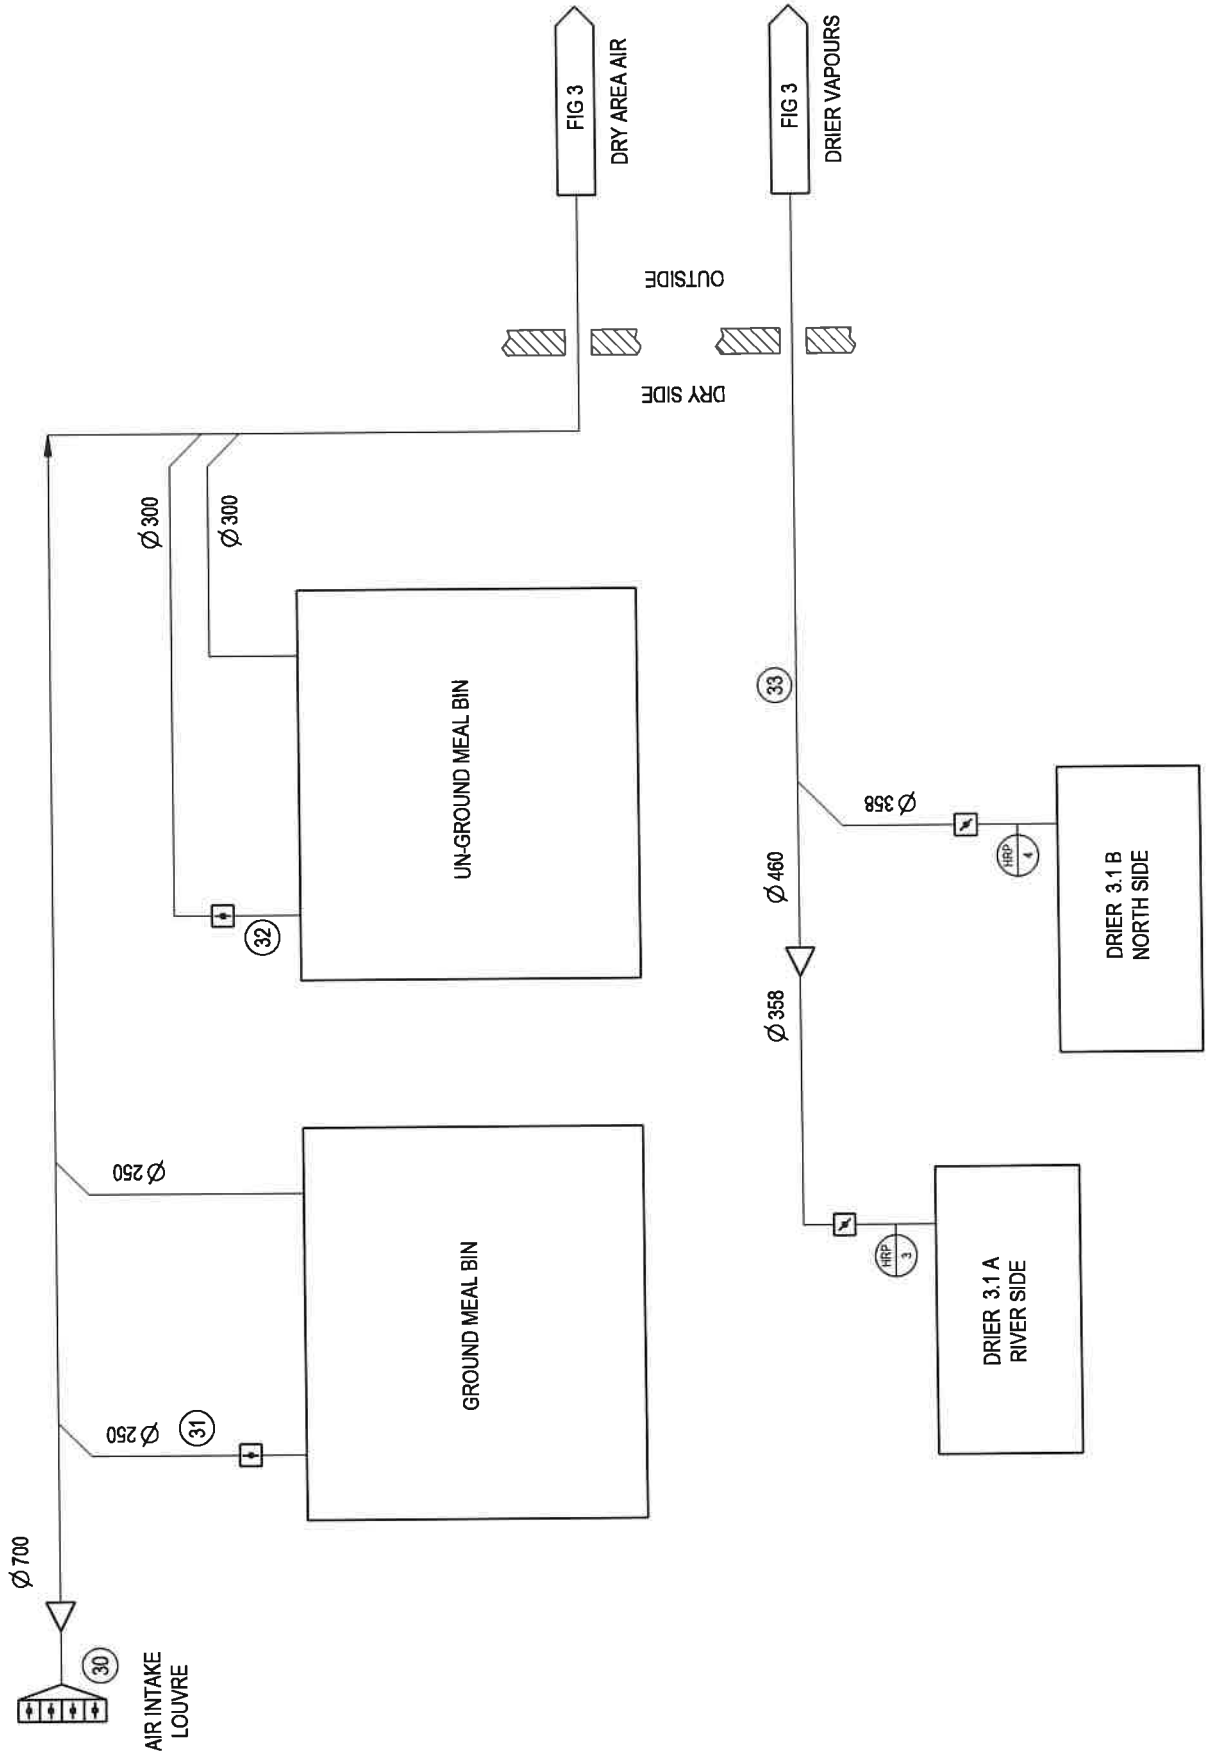
Fig 2. Dry Area Point Source Extractions at AFFCO Imlay Plant - Apr 2024

Both driers were operating for at least 30h prior to the testing except for 23 March where the plant had been shut over the weekend and restarted 8h earlier. The drier vapour duct vacuum at point 33 (Fig 2) was found to be 9 Pa. Measurement was made directly at the duct port and the fitting checked to be clear. This is lower than previous years but both driers appeared to be operating well and no puffing was seen.

2023-5	<p>Exhaust ducting from driers vacuum measuring port (33, Fig 3)</p> <p>Solids blocked fitting, needs replacement, together with new line to remote monitoring station.</p>
2023-6	<p>Review of RMF 008 Check Sheet</p> <p>Carry out a review based on a list to be provided of potential corrections and clarifications to ensure accurate meaningful monitoring occurs.</p>
2022-4	<p>Separator/Discharge Manifold and Decanter Solids Conveyor Extraction Air Balance</p> <p>Further flow measurement and calculation needed to confirm what is happening in the piping including Port 9 and Port 12 followed by further balancing if needed. Similar checks are also needed in relation to Ports 3 and 14.</p>

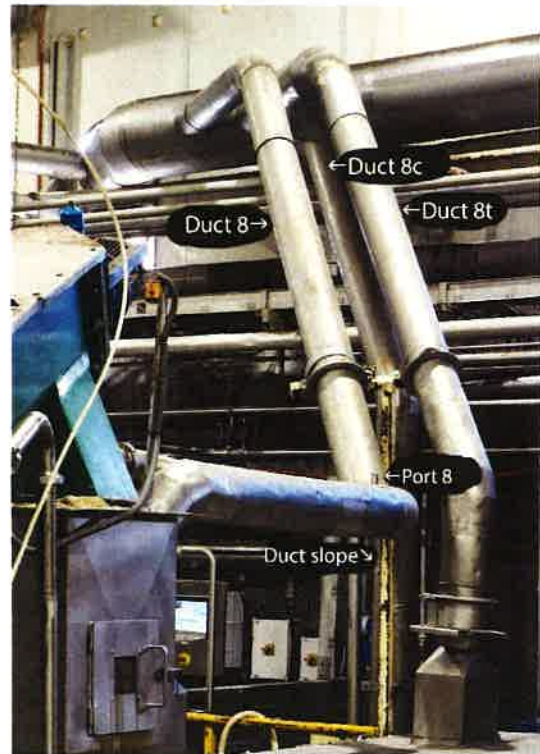
24-107: Duct 8 with upper Port 8

[Adjustment done in Nov 2023. Issue was found with duct at port 8 not being level and accumulating condensate. This affected measured velocity. A better balance was achieved but further issues were found that are still being resolved.]

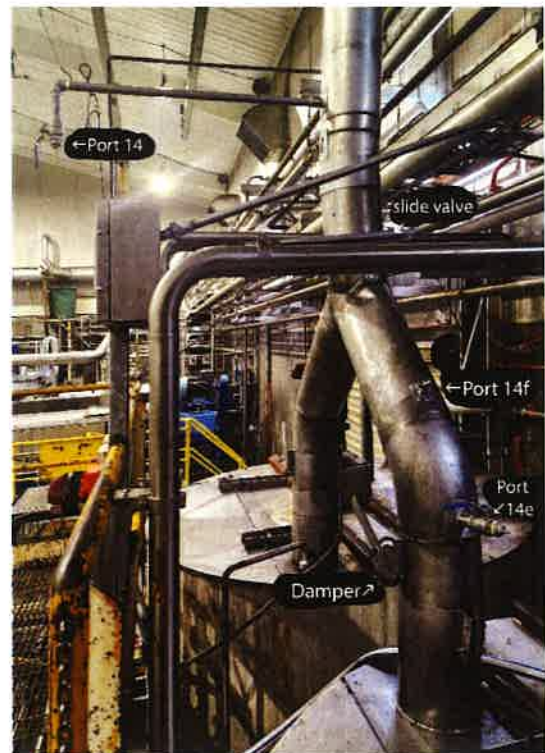
24-113: Decanter Feed Tank 2.11 ports

14	Location 14 in Fig 1.	<p>See photos 24-113 and 24-114. When vacuum monitoring was introduced the vacuum was measured at 14f seen in photo 24-113. Port 14e was later added to enable velocity measurement. By removing the valve at 14w it was also found that velocity could be measured in that branch, except misalignment of the ducts resulted in much of the air being drawn from the surrounding airspace rather than the tank 2.15. AFFCO remedied this in earlier actions. At one time the air flow from the two tanks was too high, with excessive loss of heat. Adjustment of the airflows has been made. Current damper and slide valve settings are providing adequate vacuum in the tank headspaces such that ambient air is being drawn in at all tank apertures, preventing odour escape and minimising the heat loss. From the photos it can be seen that there are essentially three vacuum zones: tank headspace vacuum; Y-branch vacuum; and manifold vacuum above the slide valve. The vacuum in the Y-branches is similar due to the connected ducts. The dampers enable trimming of extraction flows from one tank relative to the other. The vacuum measured at Port 14 is more a reflection of the vacuum in the manifold above (wet area north manifold) rather than that in the tank headspaces. It is understood that the RMF008 monitoring was moved from port 14f to 14 due to safety concerns. Monitoring at 14f required standing on the tank top - both tanks get hot during processing and a slip hazard frequently exists. Extension of the vacuum port 14 as seen in the photos enables it to be monitored at any time from the walkway. In the recent audit vacuum measurement, it was initially found that the port 14 vacuum was only 26 Pa. This was not credible and the end of the remote connection was found to be blocked. After cleaning the fitting the true vacuum was found to be 460 Pa. Another consideration is that a damper or the slide valve could be fully closed or blocked, giving no tank headspace vacuum, yet port 14 would give a good vacuum result. It is our view that the monitoring could be improved by: a) Retaining the port 14 monitoring as is, as it provides an instant accessible check on vacuum at any time during processing. b) On a weekly basis, when the tanks are not hot but the fan 14.1 is operating, poke a flexible vacuum measuring tube into each tank headspace through one of the old instrument apertures in the tank tops. The measured vacuum should be around 200 Pa with the tank lids closed. This would provide confirmation that port 14 is working and that vacuum in the tank headspaces is good.</p>

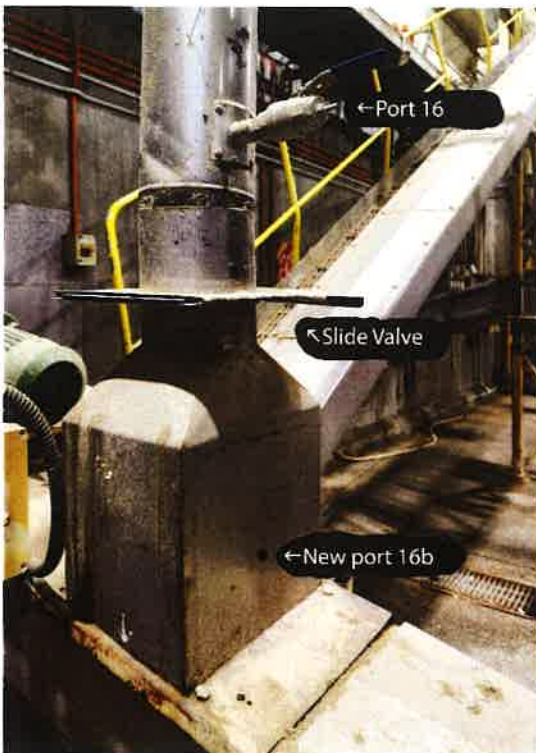
24-115: Meal Discharge Conveyor Port 16

16	Location 16 in Fig 1.	<p>In earlier reports this was port 15. It is now port 16 due to cut sheetmetal 15 identification being used for the wet area southern manifold vacuum port, as above and in Fig 1.</p> <p>Port 16 seen in photo 24-115 is prone to blockage due to the presence of dust along with high localised velocity in the vicinity of the slide valve. The vacuum measured at the port was initially 32 Pa, but after a quick unblock was around 420 Pa. The vacuum in the conveyor headspace was only around 15 Pa. It was noted that an adjacent conveyor cover plate/hatch had separated at the hinge (see photo 24-116) creating the long gap through which ambient air was inward flowing. Opening the slide valve more to achieve more headspace vacuum is unlikely to have much effect but if it did, merely hastens the rate of blockage. Reducing or eliminating the gap is needed to increase the headspace vacuum.</p> <p>Port 16 is located above the slide valve and hence gives poor indication of conveyor headspace vacuum. For improved RMF008 monitoring, a new port 16b located as shown in photo 24-115 should be provided. This is just a simple Ø6.5 mm hole in the side of the transition box which can easily be unblocked if needed and seen to be unblocked when doing the vacuum measurement.</p> <p>On the RMF008 monitoring sheet:</p> <p>a) in section 1, the 'Thursday:-Driers Manifold' should become 'Thursday:- Main Duct 15'</p> <p>b) in section 2, the 'Tues box should become '10:- Driers Manifold / 16:- Drier Discharge Conveyor'. [That is two figures be given in the Vac Result box e.g. 440/32, as these figures together give a better indication of duct blockage.]</p> <p>With the new vacuum measuring port (16b), the ball valve at port 16 can be removed and replaced by a 20 mm BSP plug. Note that this port will still be used for air velocity measurement but the valve or plug would be removed to do this.</p>
