AFFCO IMLAY

**ANNUAL AIR
DISCHARGE
MONITORING REPORT –
2023 / 2024**

AFFCO IMLAY WANGANUI

AIR DISCHARGE PERMIT:-
ATH-2007010926.01

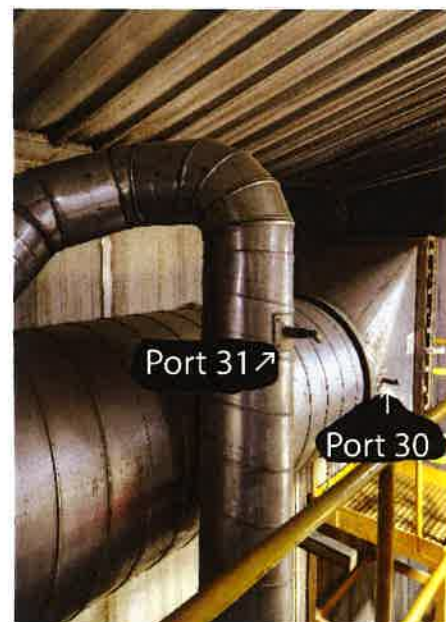
24-118: Ports 30 and 31 in Fig 2

30	Location 30 in Fig 2.	<p>See photo 24-118. This is the vacuum monitoring port immediately downstream of the air intake flow adjusting louvre and gives around 70 - 80 Pa when the louvre is clean. It is obvious when the louvre needs cleaning and lower vacuum readings typically indicate that the port fitting is blocked. Air flow into the duct is measured at the louvre face so the port is good as is.</p>
31	Location 31 in Fig 2.	<p>See photos 24-118 and 24-119. This port was originally installed for monitoring the ground meal bin headspace vacuum. It is located downstream of the slide valve; is prone to blockage; another parallel duct which has no slide valve also extracts air from the bin headspace; and the port is unable to be used for velocity measurement because it is too small.</p> <p>The top of the bin is covered with a fabric blanket. Only a small amount of vacuum in the bin headspace is needed (contrary to one Consent requirement) to remove off-gassing odour from the meal without entraining excessive meal dust into the extraction system. The headspace vacuum can be measured by inserting a flexible sensing tube under the blanket. A more reliable measure for RMF008 monitoring is to use a simple Ø6.5 mm hole in the duct wall just below port 31 so it is readily accessible. Also a similar hole to be provided at a similar location in the parallel duct. These holes will give a higher vacuum than in the bin headspace but give larger numbers for comparison. The existing Port 31 should be replaced with a Fig 5 type port which will enable air velocity in the duct to be measured. Similarly, another Fig 5 type port should be installed on the parallel duct. These new ports can be designated 31w and 31e (west and east) to distinguish them. Until they are installed they will not be shown in Fig 2.</p> <p>Although the measured velocities will be low, their determination matters to achieve the balance between good odour removal without entraining excessive dust and knowing what is happening in each duct. At present the only measure of bin extraction flows has been difference between the airflow at the scrubber less the airflow from the reception bin and the dryside air intake.</p> <p>In summary what is required is:</p> <p>a) a Fig 5 type port for air velocity measurement, in both ducts, located where port 31 is at present and at 31e as in photo 24-119, and b) a simple Ø6.5 mm diameter hole in each duct wall about 50 mm below the new ports for the RMF008 vacuum measurements.</p>
